DASCO CHECK AND BLEEDER VALVES

REDUCE ESP DOWNTIME & SURFACE CONTAMINATION

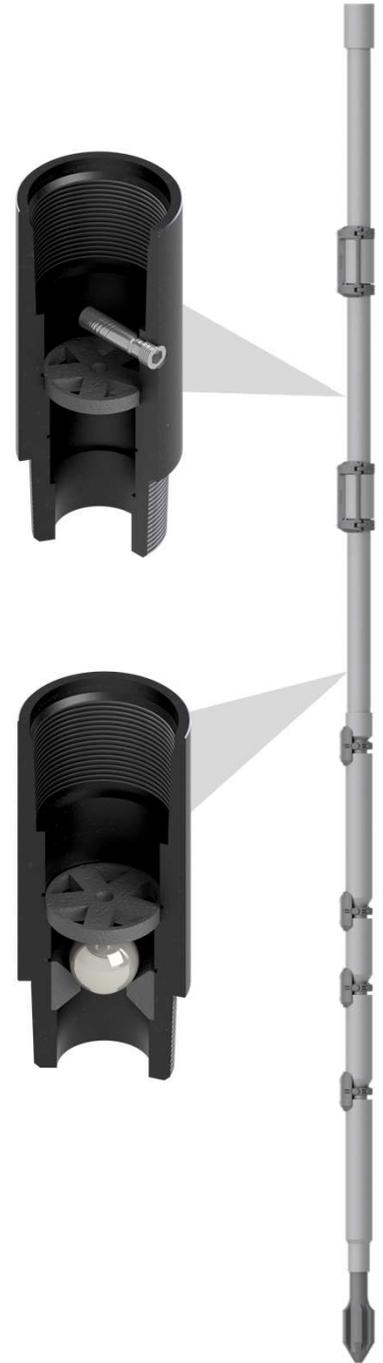
Without a check valve, when the ESP is turned off the pump is driven backwards as the remaining fluid column in the production tubing equalizes with the annulus. The pump cannot be started until this equalization is complete to avoid damage to ESP components. With a DASCO CHECK VALVE installed, the ESP can be restarted immediately against a full column of fluid.

When an ESP is plugged due to sand or other foreign material, it traps all fluids inside the production tubing. A 2000m (~6500 ft) deep well using 2 7/8" tubing contains approximately 6 M3 (38 bbl) of fluid. When pulled wet, fluid handling at surface becomes a time consuming and expensive task. With a DASCO BLEEDER VALVE installed, a bar is simply dropped down the production tubing and shears off the drain plug before pulling the ESP, providing a tubing drain into the annulus thereby eliminating the need to pull wet tubing.

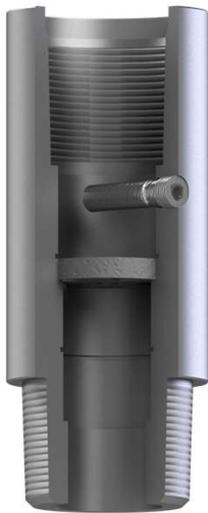
Never pull wet tubing again

The DASCO BLEEDER VALVE reduces surface fluid handling costs and contamination associated with pulling wet tubing by providing operators with a reliable way to drain production tubing before pulling the ESP from the wellbore, keeping environmentally harmful fluids inside the wellbore.

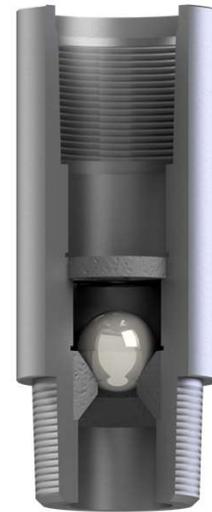
Stop waiting for production

The DASCO CHECK VALVE is used to reduce ESP downtime between start-ups by eliminating lengthy wait times associated with back spinning ESP's.
